Blessed Sacrament Church

Hyde Square | Jamaica Plain, MA

Conditions Assessment Report

RSA Project #15973 | 18 July 2014

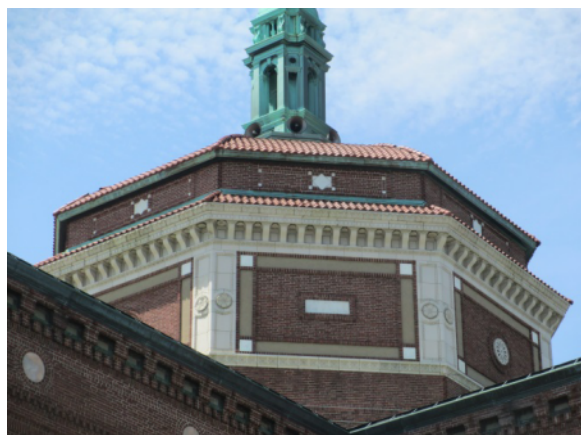
Figure 20. Blessed Sacrament Dome

The dome is supported by an octagonal masonry drum highlighted in blue in Figure 6 and seen in Figure 20 on the following page. Partial mortar loss at the corners of the octagon revealed steel embedded columns in the topmost portion of the drum. These columns deliver the roof framing loads down the first steel ring embedded in the masonry. Overall, the masonry appears to be structurally sound; the embedded steel shows no outward signs of deterioration or movement, which would be translated onto the masonry elevations. There is a major area of masonry deterioration, at the drum, though it is most likely the result of improper through-wall flashing.

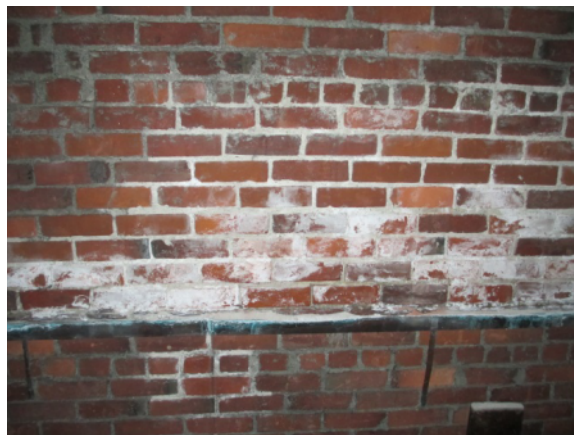
Figure 21. Efflorescence at Interior of Drum

There is significant efflorescence in a band at the upper portion of the drum, approximately four to five feet below the top of the masonry drum (Figure 21). Upon closer review, this area has significant mortar degradation and loss; the mortar that remains is a powdery substance that is easily washed or blown away. This area of deterioration lies directly above the copper through-wall flashing. The advanced state of brick and mortar damage is most likely due moisture infiltration through this through-wall flashing joint. The through-wall flashing creates an open joint for moisture to enter through the wall; this constant water infiltration has accelerated the mortar deterioration in this location. There does not appear to be noteworthy cracking or spalling of brick that coincides with this mortar deterioration and efflorescence; therefore, RSA believes this is most likely an envelope condition due to improper through-wall flashing.

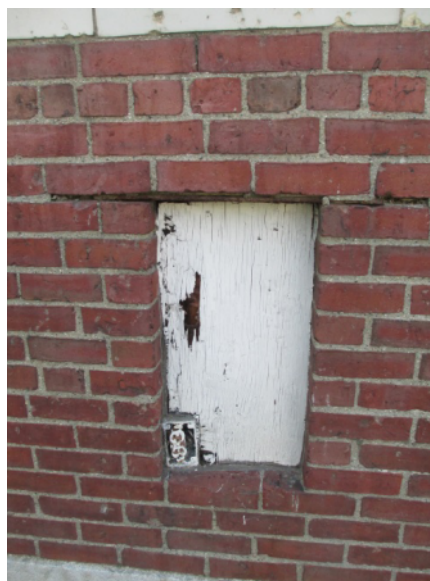
Figure 23. Steel Lintel, Representative Condition

The main church roof is supported by steel columns embedded in the masonry clerestory walls highlighted in blue in Figure 13. The walls are in fair condition, with minor vertical cracking seen in the mortar joints between the clerestory windows (Figure 22). This is most likely attributed to freeze-thaw effects of moisture infiltration through the brick-work that is cladding the embedded steel. The interiors of the steel columns (seen from the attic) do not show any signs of water issues or rusting (discussed later in this report). The masonry appears to be structurally sound, and the cracking seen will be alleviated with proper envelope repair. The steel lintels above the windows show minor signs of rust and deterioration, typical of exterior steel exposed to the elements (Figure 23).

Building Component	Condition	Recommendations
Window Lintels	The windows lintels show minor signs of rust, typical of exposed steel.	All the window lintels should be scraped, primed and repainted. The brick around the lintels should be reviewed to ensure no rust jacking is occurring at the lintel bearing ends.

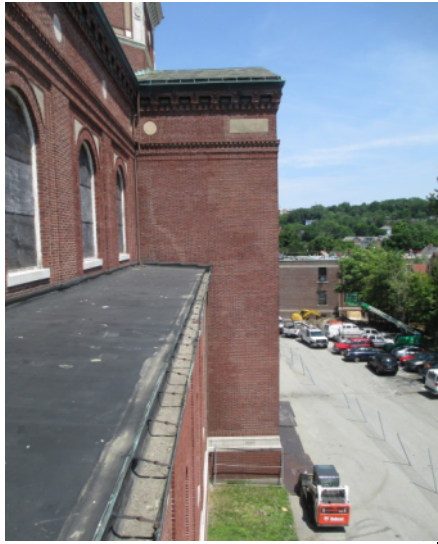
Figure 24. East Transept Return Wall from Centre Street

The transept roofs are supported by full height masonry walls. Overall the masonry appears structurally sound, with no major areas of cracking, mortar loss, or efflorescence and only one localized area of brick loss. Envelope repair by means of repointing is visible on the north elevations (Figure 24) of both transepts.

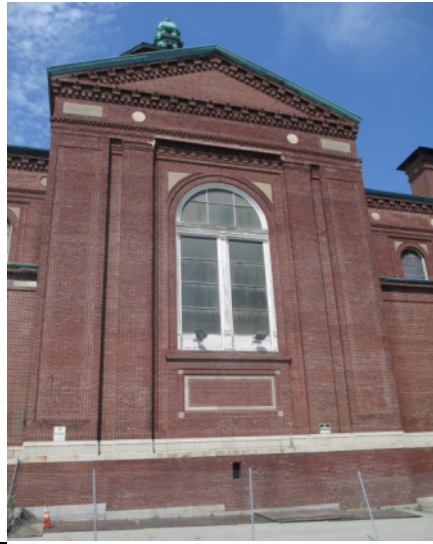
Figure 25. East Transept Wall

An entire decorative soldier course of brick above the window of the east transept wall spalled off at some point in the past (Figure 25). A steel channel is left in its place; repair brick above and at the sides of the channel indicate that this channel may have been an addition to help support the brick coursing that was once supported by the previously spalled bricks (Figure 26). The west transept gives us a clue as to how the brickwork is supposed to look and function above the window (Figure 27).

The channel at the east transept – completely exposed to the elements – is in an advanced state of deterioration. Rust is evident from grade and pitting can be seen along the underside of the bottom flange. The channel appears to be supporting the replacement brick adequately, though a closer inspection (by means of a lift) would properly identify its current structural condition. The lower steel lintels over the windows show signs of rust and minor deterioration, similar to the typical weathering seen at the clerestory.

East Transept Lintel	A band of brickwork has spalled off and a steel channel inserted in its place to support the above decorative brickwork. The channel appears to be deteriorated – though the extent is unknown.	Access by means of a lift is recommended in this area to determine how deteriorated the steel channel support is and if the surrounding brickwork is damaged. If visual inspection reveals the steel to no longer providing the necessary support for the brickwork, the area should be immediately shored.

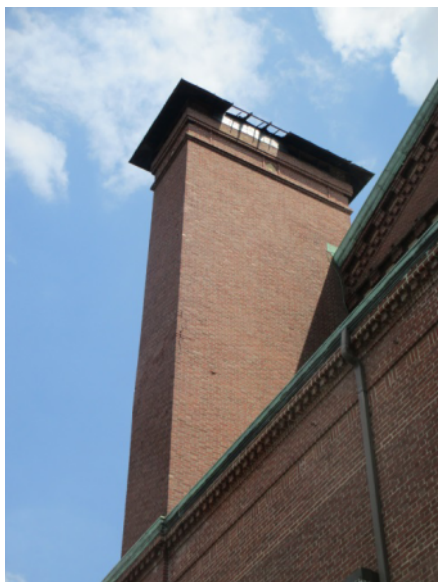
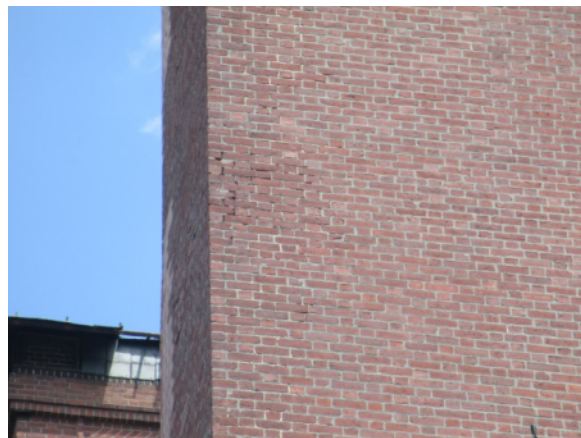
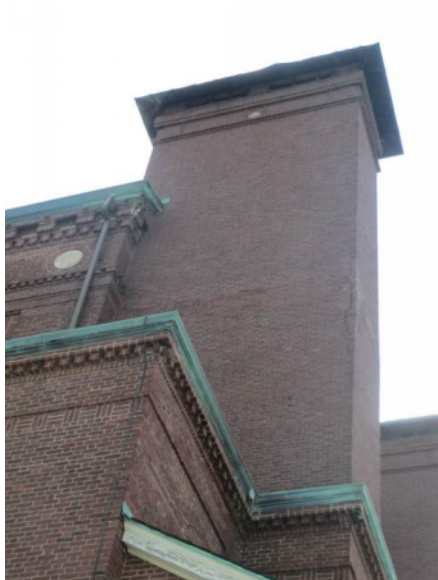
From grade, both the east and west flue stacks show signs of masonry degradation. The northeast flue stack shows cracking, spalling, and bowing at the northernmost corners at an elevation roughly in line with the top of the clerestory windows (Figures 30, 31, and 32). The northwest flue stack has obvious repairs that are in line with the deterioration seen at the east flue stack (Figure 33). It should also be noted, that there was a significant amount of brick rubble in the basement at the base of the flue stacks (Figure 34). An interior review of the flue stacks showed an existing opening at the first floor that has since been blocked up with CMU (Figure 35). A closer review of these stacks is necessary to understand the severity of the situation.

Figure 30. Northeast Flue Stack Exterior

Figure 31. Northeast Flue Stack Brick Damage (Close-up)

Figure 32. East Elevation of Northeast Flue Stack
Showing Brick Bulging Out of Plane

Building Component	Condition	Recommendations
Brick Flue Stacks	From grade, both flue stacks show significant bowing, cracking, and spalling.	Further investigation and analysis is recommended to assess the stability of the flue stacks. Access by means of a lift would allow a closer review of the extent of brick damage. Should it be found that the stacks are in a serious state of instability, immediate steps must be taken to stabilize them. Once stable, a proper repair campaign can be mapped out.
Sacristy Roof	The sacristy roof is visibly sagging and the condition of the roof framing is currently unknown.	Access to this area is recommended to determine the stability of this roof structure. The framing is to be reviewed to determine whether or not this is the failure of just the roofing material or the roof framing system as well. Should it be determined that the roof framing has collapsed, the area should be cautioned off immediately and temporary shoring should be inserted to stabilize the area.

Building Component	Condition	Recommendations
Brick Flue Stacks	From grade, both flue stacks show significant bowing, cracking, and spalling.	Due to the extent of cracking on the east flue stack and the attempted repair on the west flue stack it should be assumed that repairs could include a full rebuild of the upper portion of the flue stacks or the introduction of new structure to help support the upper portion of the flue stacks. This program would be secondary to an immediate stabilization of the flues should further investigation reveal them to be in an advanced state of deterioration.
Sacristy Roof	The sacristy roof is visibly sagging and the condition of the roof framing is currently unknown.	The roof that has collapsed and should be removed and replaced. If further investigation reveals failure of the roof framing, a new roof structure must be designed and implemented.
East Transept Lintel	A band of brickwork has spalled off and a steel channel inserted in its place to support the above decorative brickwork. The channel appears to be deteriorated – though the extent is unknown.	Depending upon the severity of the condition, repairs could range from the removal of the steel channel and localized brick repair to a complete removal and replacement of several brick courses in order to stabilize the masonry in this location.

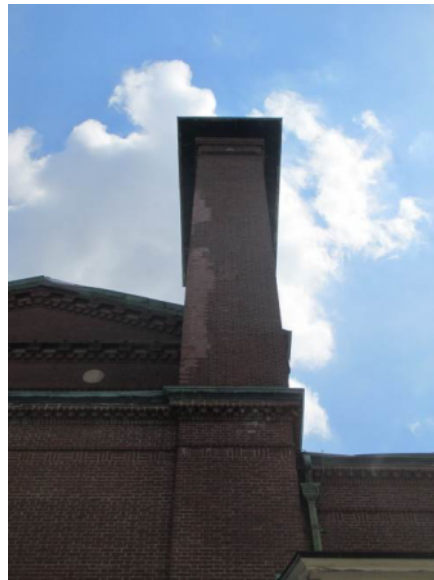
Figure 33. Northwest Flue Stack Brick Replacement

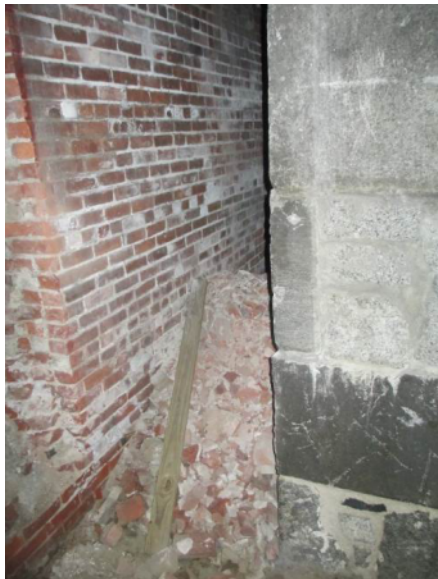
Figure 34. Brick Rubble at Base of Flue Stack

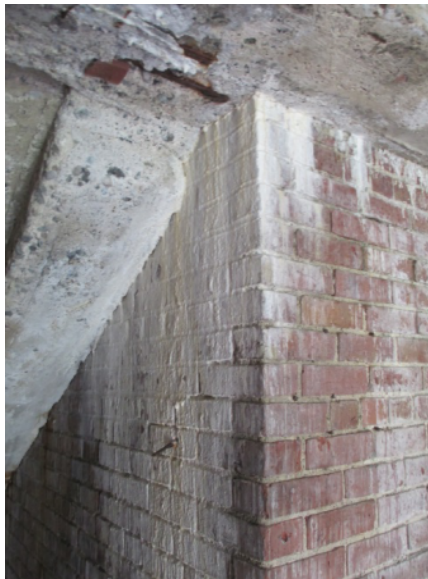
As a part of the façade, there are two reinforced concrete and masonry stairs leading into the rear of the church (Figures 36 and 37). These stairs were added at a later date, evidenced by a joint between the original building envelope and the stair envelope. There is a storage closet beneath the northwest stair which provided access to review the underside of the stair (Figure 38); the area beneath the northeast stair was inaccessible at the time. These stairs are in poor condition. The northwest stair has major spalling of the concrete beams and piers that frame the stair and a fair amount of exposed rebar. There is also severe efflorescence on the underside of the stair (Figures 39 and 40). Additionally, there is a major step crack in the exterior masonry wall (Figures 37), although it isn't as visible on the interior (Figure 41). Similar damage is present at the northeast stair, although not to the same extent. This damage is most likely a result of moisture infiltration issues.

Figure 40. Efflorescence Deposition on Building Wall

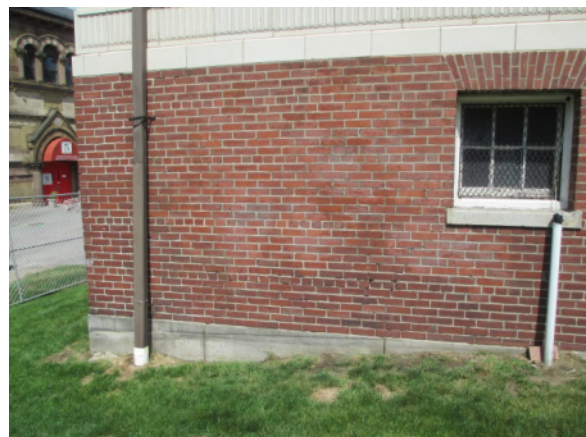
The sacristy masonry appears to be structurally sound, with no major areas of cracking, mortar loss, spalling or efflorescence (Figure 42). Nearly all steel lintels show minor signs of rust, but the brickwork around them appears to be in good condition. There is a minor step crack from the lower corner of the northern most basement window on the west façade of the sacristy (Figure 43).

Figure 43. Northwest Corner With Minor Step Cracking

Baptistery Lintel	There is a minor step crack beginning from the lower corner of the northern most basement window on the west façade of the sacristy, indicative of a more significant level of rust jacking at bearing end of this steel lintel	Lintel is to be scraped, primed and painted. Bearing ends are to be locally rebuilt once the steel is properly recoated.

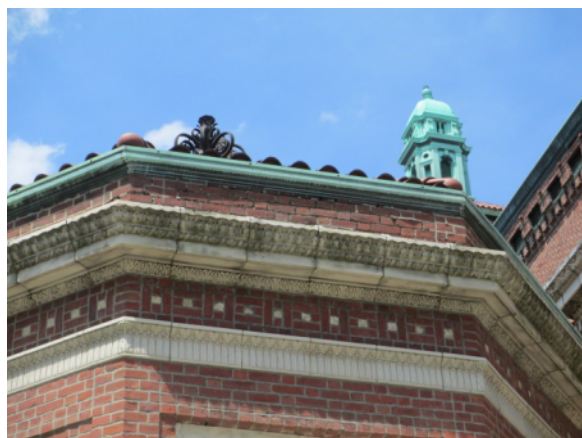
Figure 44. Baptistry Upper Band of Masonry

The Baptistry masonry is in poor condition, with large areas of cracking and mortar loss. The upper band of masonry has significant mortar loss and small areas of spall (Figure 44). Additionally, there are large open joints on the northeastern façade of the Baptistry in the mortar joints separating the soldier course at the corner of the octagon from the Flemish bond (Figures 45 and 46). The open joints run the full height of the wall (from the lower band of decorative terra cotta to the base of the brickwork). The masonry bearing walls of the Baptistry were not visible from the interior; however the interior space was extremely damp and humid, with severe water damage to the decorative finishes (Figure 47).

Baptistery Masonry	The Baptistery masonry is in poor condition, with large areas of cracking and mortar loss. The upper band of masonry has significant mortar loss and small areas of spall. Additionally, there is a large open joint on the northeastern façade.	Refer to DBVW's report for recommendations on masonry envelope elements. Further investigation, possibly with some moisture monitoring and invasive probing into the open joint, is recommended to determine the makeup of the walls to determine whether repairs are either localized brick repair or complete disassembly and rebuild.
Rear Church Stairs	The two reinforced concrete and masonry stairs leading into the rear of the church are in poor condition, with areas of cracking, movement and severe concrete deterioration.	These stairs should be repaired. The concrete landing and steps that are severely cracked and deteriorated should be recast and the brick walls rebuilt.

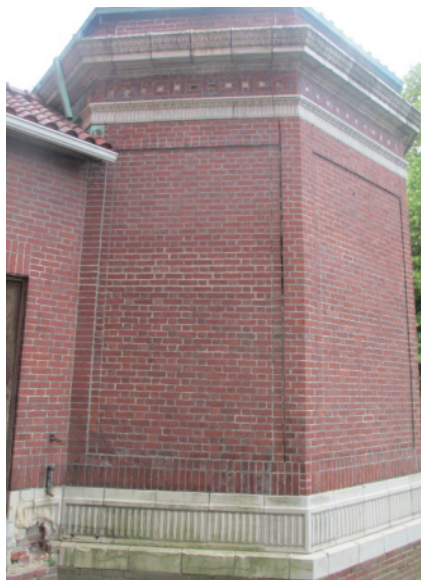
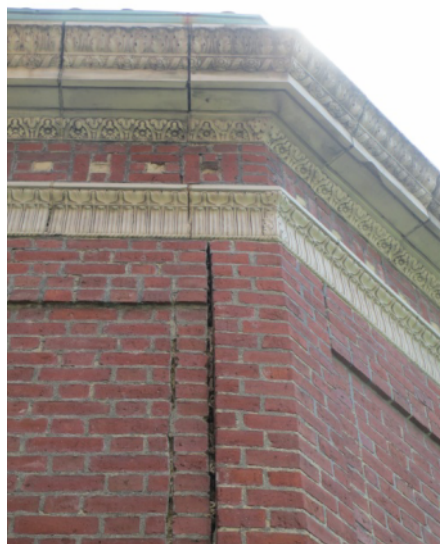
Figure 46. Close-up of Brick Separation at Northeast Elevation

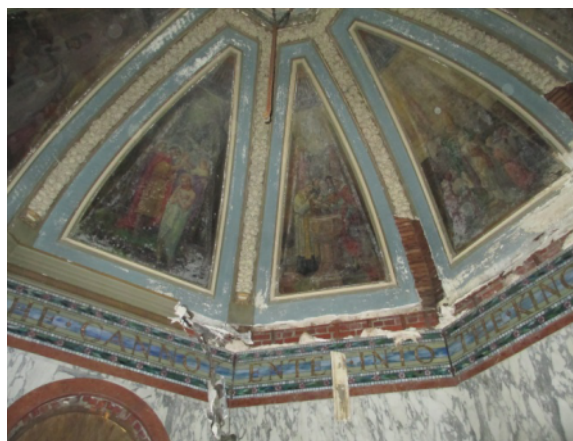
Figure 47. Plaster Damage on the Interior of the Baptistry

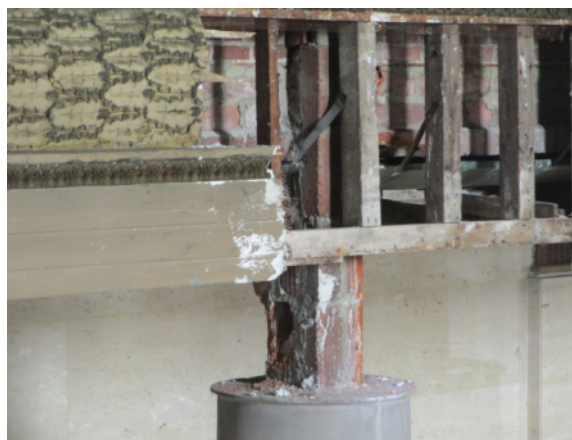
Figure 49. Exposed Top of Steel Clerestory Column

The clerestory steel columns can be seen from the attic and appear to be in good condition; there are no outward signs of deterioration and the brickwork around the steel's embedment shows no signs of cracking or movement. Similarly, the small portions of steel that were visible inside the church were in good condition. It appears the terra cotta and brick around the spandrel beams and interior columns provided coverage and protected the steel elements from the moisture infiltrations affecting the decorative plaster (Figure 49).
