Blessed Sacrament Church

Hyde Square | Jamaica Plain, MA

Conditions Assessment Report

RSA Project #15973 | 18 July 2014

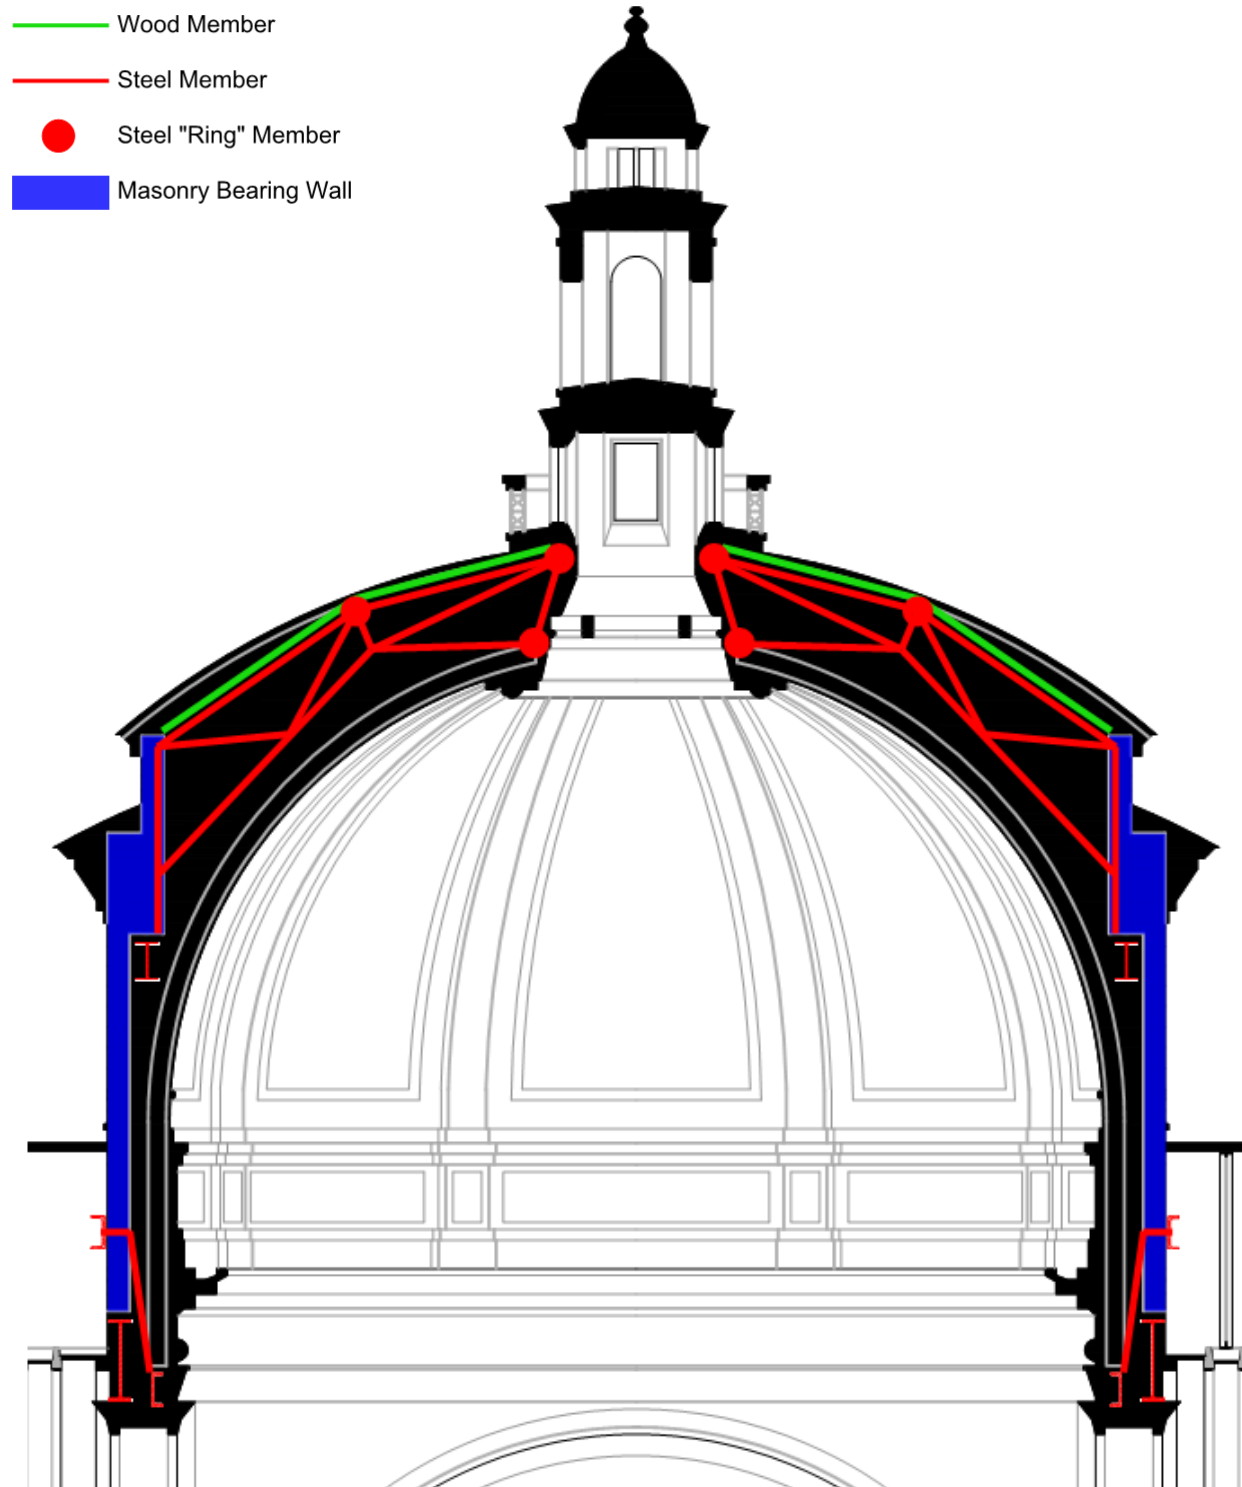
The roof framing of the octagonal belvedere dome is shown schematically in Figure 6 below. The dome consists of wood rafters spaced at roughly 16" on center, set square to the edge of the octagon, and supported by a steel trussed dome structure. The steel dome structure consists of 8 radial steel trusses (Figure 7) connected by a series of steel members that form "rings" connecting the trusses at varying locations. These "rings" are indicated by red nodes in Figure 6. The rafters are set at two different angles (Figure 8) to create the dome roof with the higher rafters being supported fully by steel rings at either end, and the lower rafters being supported by a steel ring at the high end and framing into the masonry bearing wall forming the drum of the dome at the low end. It appears that within the masonry walls of the octagonal drum of the dome there are a number of steel truss elements. The radial trusses include a vertical member that is encased in the masonry and located at the vertex of the octagon. Additionally, there are at least two rings of terra cotta encased steel beams that support the walls of the drum and serve as tension rings to resist the thrust of the radial trusses (Figure 9). There is also a series of steel hangers supported by channels on the outside of the drum walls from which a steel ring is hung to support the ceiling of the dome (Figures 10 and 11). The radial trusses are composed mainly of steel angles with the "ring" members being either channels (Figure 12) or wide flanges. The truss connections are typically bolted connections.

Figure 6. Section through Dome showing Schematic Structure

The roof framing at the dome appears to be in good condition. The condition of the wood rafters and steel structural elements show minimal signs of weathering, which is consistent with the general material characteristics and age of the structure. Though there are many separate elements (wood rafters, radial steel trusses, steel rings - both exposed at the roof and embedded lower within the masonry dome) that create a complex and intricate structural framing system, RSA believes the dome framing provides is adequately framed, providing an acceptable load path to translate the loads down to the vertical structural elements (explained above), and its condition is consistent with the church's age of construction.

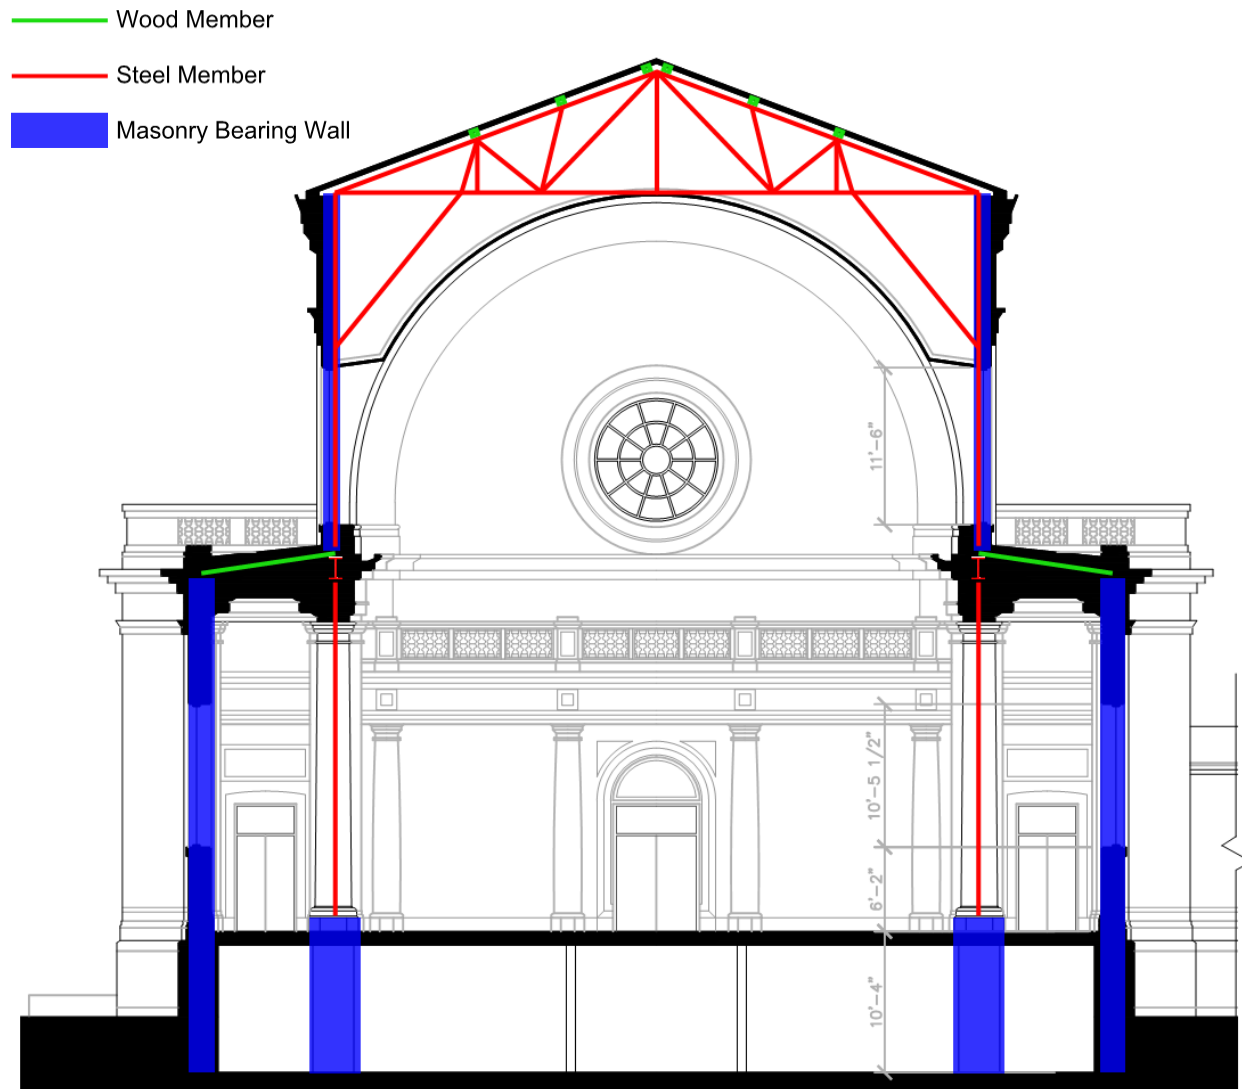
The roof framing of the main church over the nave is shown schematically below in Figure 13. It consists of 6 heavy timber rafters, roughly 10" wide by 12" deep, running the length of the nave (North-South) supported by triangular steel trusses (Figure 14). There are two rafters forming the roof ridge; two intermediate rafters support each side of the sloping roof that spans from the ridge to the clerestory masonry walls. The rafters bear on the steel trusses where vertical or diagonal members frame into the trusses' top chords (Figure 15). The steel trusses frame into plate-girder columns embedded in the clerestory masonry bearing walls (Figures 16 and 17), which are then supported on interior spandrel beams (discussed in later sections of the report). The trusses are spaced such that they are centered between clerestory windows.

Similar to what was observed at the dome, the roof elements appear to be in good condition. No water damage was noted. The layout and member sizes of the roof structure appear to be structurally adequate for the observed loading conditions.

Figure 13. Section through Nave showing Schematic Structure

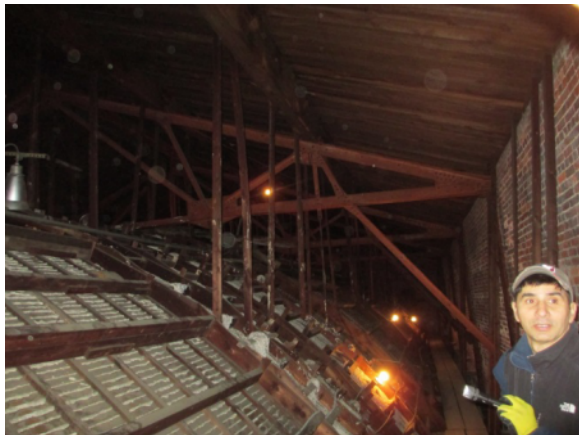
Figure 14. Steel Roof Truss

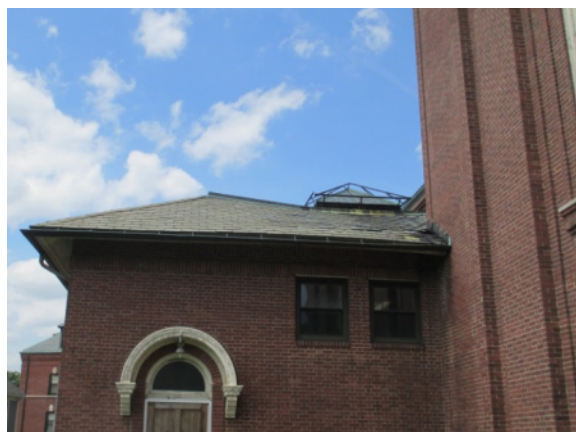
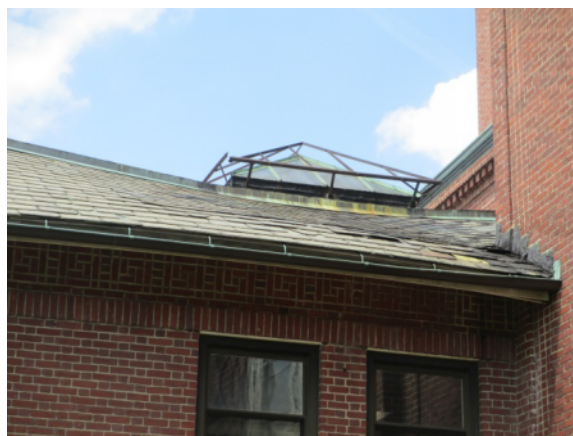
The Sacristy roof is a flat, mansard roof roughly six feet deep. The roof is wood-framed; however the exact framing configuration was not visible. There was very limited access to the Sacristy roof due to the large height difference between the drop ceiling and roof framing; the available ladders on site could not bridge this gap. A large opening for a skylight had been cut in the sacristy roof at some point after the Sacristy's construction. There is significant sagging of the Sacristy roof in the area surrounding this skylight. This sagging is visible from the exterior (Figures 18 and 19). Since the framing could not be viewed up-close, it could not be confirmed whether or not the roof framing is structurally failing in this location. Access should be provided in order to review the condition of the roof framing in this location; until then, this area should not be accessible to patrons and proper caution should be taken by all staff that must access areas in the Sacristy.

Figure 18. Sacristy Roof with Skylight

Figure 19. Sacristy Roof with Skylight

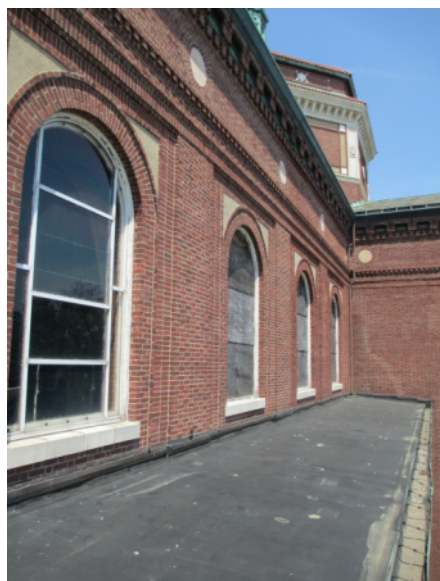
The main church roof is supported by steel columns embedded in the masonry clerestory walls highlighted in blue in Figure 13. The walls are in fair condition, with minor vertical cracking seen in the mortar joints between the clerestory windows (Figure 22). This is most likely attributed to freeze-thaw effects of moisture infiltration through the brick-work that is cladding the embedded steel. The interiors of the steel columns (seen from the attic) do not show any signs of water issues or rusting (discussed later in this report). The masonry appears to be structurally sound, and the cracking seen will be alleviated with proper envelope repair. The steel lintels above the windows show minor signs of rust and deterioration, typical of exterior steel exposed to the elements (Figure 23).

Figure 22. Blessed Sacrament East Clerestory

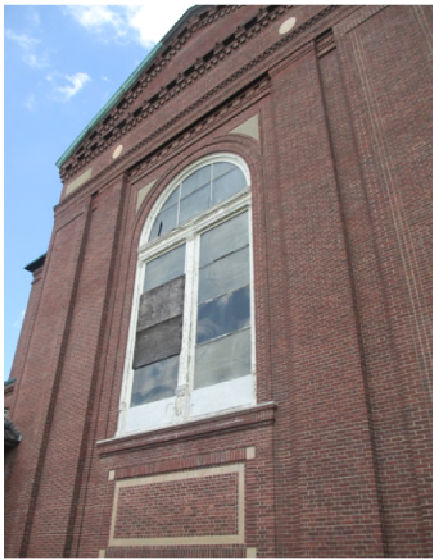
An entire decorative soldier course of brick above the window of the east transept wall spalled off at some point in the past (Figure 25). A steel channel is left in its place; repair brick above and at the sides of the channel indicate that this channel may have been an addition to help support the brick coursing that was once supported by the previously spalled bricks (Figure 26). The west transept gives us a clue as to how the brickwork is supposed to look and function above the window (Figure 27).

Figure 27. West Transept Wall

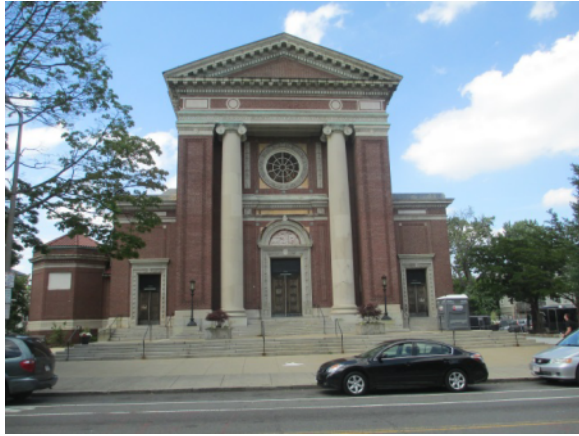
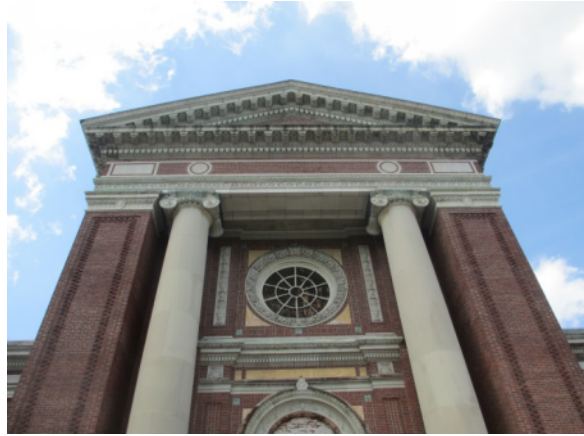
The front facade masonry was reviewed from grade and appears to be structurally sound, with no major areas of cracking, mortar loss, spalling or efflorescence (Figures 28 and 29).

Figure 28. Blessed Sacrament Front Façade

Figure 29. Blessed Sacrament Front Façade

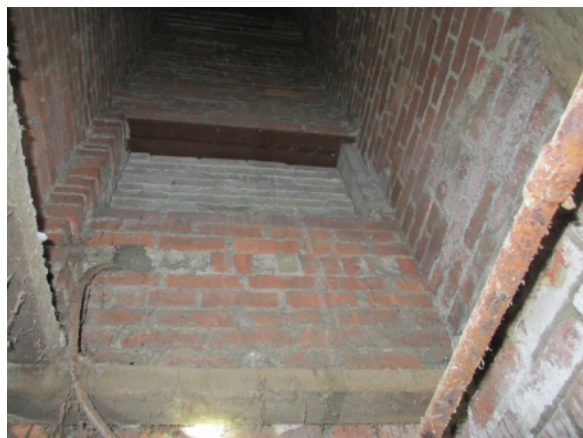
From grade, both the east and west flue stacks show signs of masonry degradation. The northeast flue stack shows cracking, spalling, and bowing at the northernmost corners at an elevation roughly in line with the top of the clerestory windows (Figures 30, 31, and 32). The northwest flue stack has obvious repairs that are in line with the deterioration seen at the east flue stack (Figure 33). It should also be noted, that there was a significant amount of brick rubble in the basement at the base of the flue stacks (Figure 34). An interior review of the flue stacks showed an existing opening at the first floor that has since been blocked up with CMU (Figure 35). A closer review of these stacks is necessary to understand the severity of the situation.

Figure 35. Previous Opening in Flue Stack Blocked Up

Building Component	Condition	Recommendations
Brick Flue Stacks	From grade, both flue stacks show significant bowing, cracking, and spalling.	Further investigation and analysis is recommended to assess the stability of the flue stacks. Access by means of a lift would allow a closer review of the extent of brick damage. Should it be found that the stacks are in a serious state of instability, immediate steps must be taken to stabilize them. Once stable, a proper repair campaign can be mapped out.
Sacristy Roof	The sacristy roof is visibly sagging and the condition of the roof framing is currently unknown.	Access to this area is recommended to determine the stability of this roof structure. The framing is to be reviewed to determine whether or not this is the failure of just the roofing material or the roof framing system as well. Should it be determined that the roof framing has collapsed, the area should be cautioned off immediately and temporary shoring should be inserted to stabilize the area.

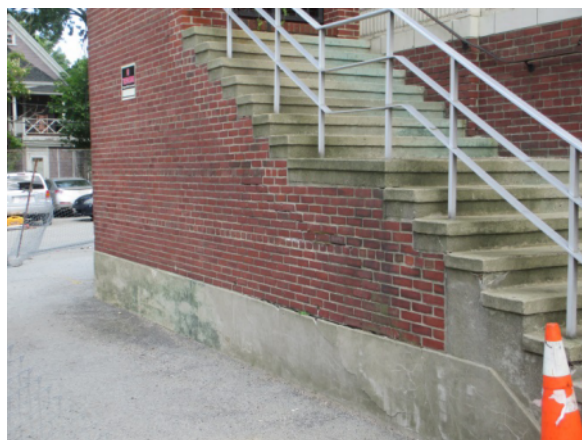
As a part of the façade, there are two reinforced concrete and masonry stairs leading into the rear of the church (Figures 36 and 37). These stairs were added at a later date, evidenced by a joint between the original building envelope and the stair envelope. There is a storage closet beneath the northwest stair which provided access to review the underside of the stair (Figure 38); the area beneath the northeast stair was inaccessible at the time. These stairs are in poor condition. The northwest stair has major spalling of the concrete beams and piers that frame the stair and a fair amount of exposed rebar. There is also severe efflorescence on the underside of the stair (Figures 39 and 40). Additionally, there is a major step crack in the exterior masonry wall (Figures 37), although it isn't as visible on the interior (Figure 41). Similar damage is present at the northeast stair, although not to the same extent. This damage is most likely a result of moisture infiltration issues.

Figure 36. Northeast Entrance Stair

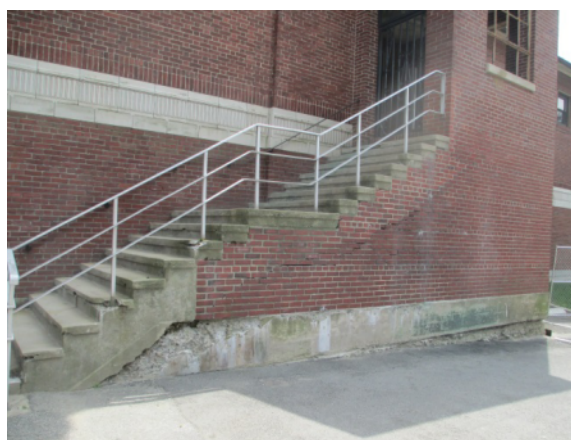
Figure 37. Northwest Entrance Stair

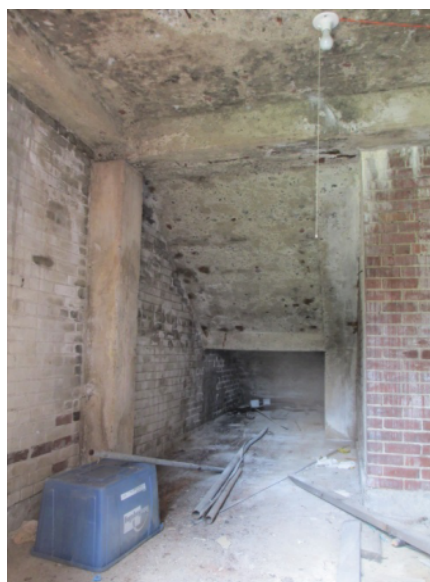
Figure 38. Storage Space Beneath Northeast Entrance Stair

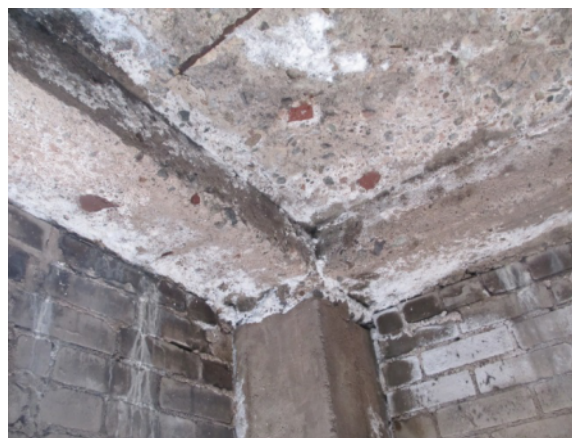
Figure 39. Underside of Northwest Entrance Stair Slab

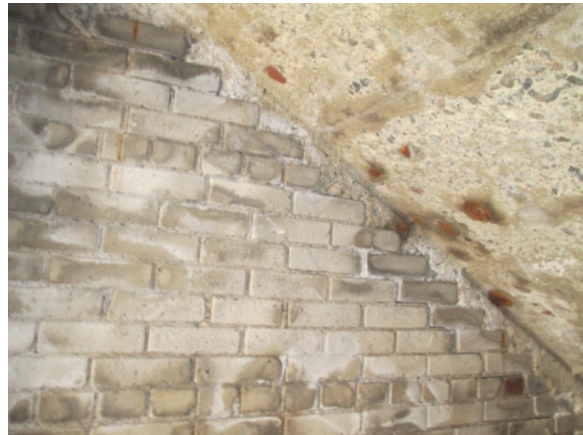
Figure 41. Interior Elevation of Northeast Stair Brick Wall

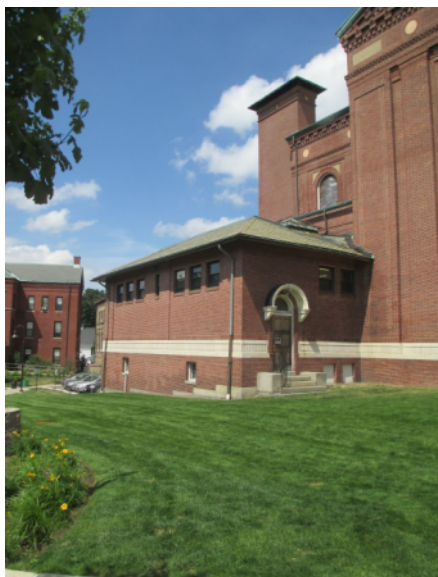
The sacristy masonry appears to be structurally sound, with no major areas of cracking, mortar loss, spalling or efflorescence (Figure 42). Nearly all steel lintels show minor signs of rust, but the brickwork around them appears to be in good condition. There is a minor step crack from the lower corner of the northern most basement window on the west façade of the sacristy (Figure 43).

Figure 42. Sacristy Exterior View

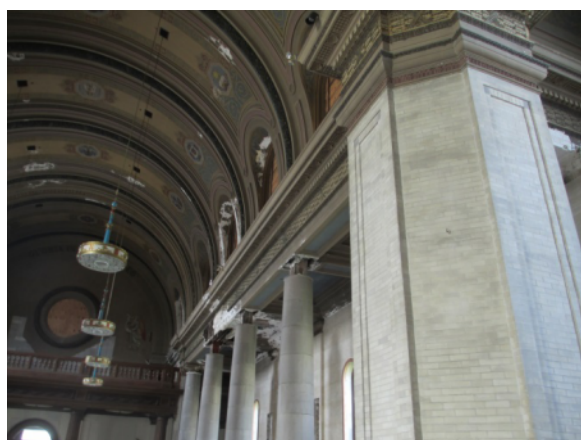
The clerestory steel columns can be seen from the attic and appear to be in good condition; there are no outward signs of deterioration and the brickwork around the steel's embedment shows no signs of cracking or movement. Similarly, the small portions of steel that were visible inside the church were in good condition. It appears the terra cotta and brick around the spandrel beams and interior columns provided coverage and protected the steel elements from the moisture infiltrations affecting the decorative plaster (Figure 49).

Figure 48. Church Interior Showing Location of Clerestory Columns

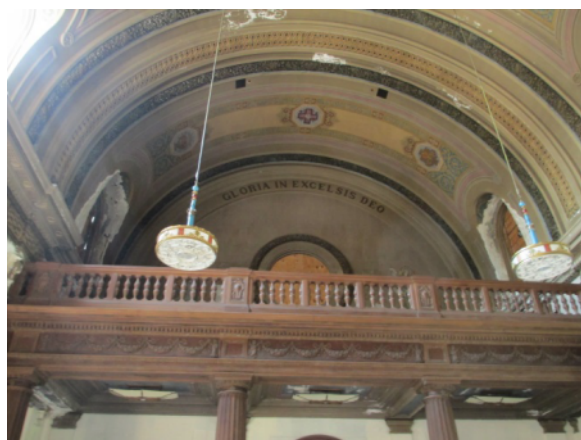
The organ gallery level is a partial mezzanine at the southern end of the nave (Figure 50). It is supported by a combination of four interior steel columns, interior piers and perimeter masonry bearing walls. There was limited access to the organ gallery floor framing; localized portions of framing were visible from two small probes that had already been opened in the organ gallery floor. The probes revealed east-west steel beams spanning between steel columns and/or brick piers at the north end of the mezzanine. The organ gallery floor framing consists of two bays of wood joists that frame between these steel elements at the north end and the masonry bearing walls to the south. The joists are two different sizes in the two bays: 1 3/4" x 9" wood joists spaced at 16" on center and 2" x 14" wood joists spaced at 16" on center. This is consistent with the two different length spans present at the organ gallery level. From the limited area of review, it appears that both the wood and steel elements of the organ gallery framing are in good condition with no visible signs of structural instability or material deterioration.

Figure 50. Organ Gallery

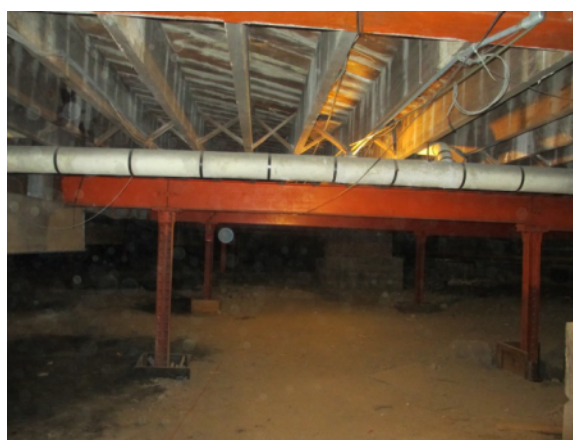
The first floor framing was visible from the unexcavated basement space the full length of the church (Figure 51). The exposed ground floor framing consists of wood joists that span between east-west running steel beams (Figure 52); these beams span between interior steel columns, interior brick piers and the perimeter exterior masonry bearing walls. The steel beams range in size from small 6" channels to deep 18" W-shapes based on their spans and the amount of flooring they are supporting. This floor framing is quite regular, with the

Figure 51. Underside of First Floor Framing from the Basement

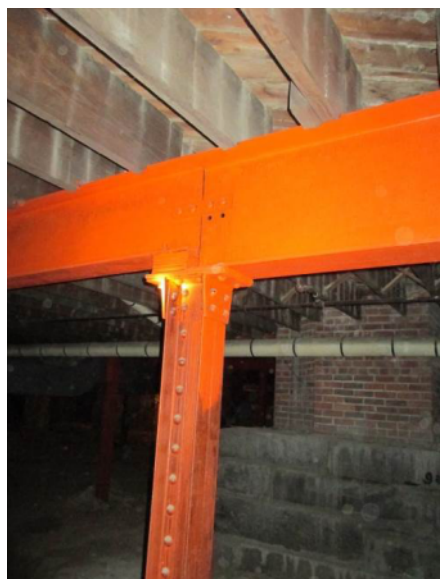
Figure 52. First Floor Interior Steel Beams and Column

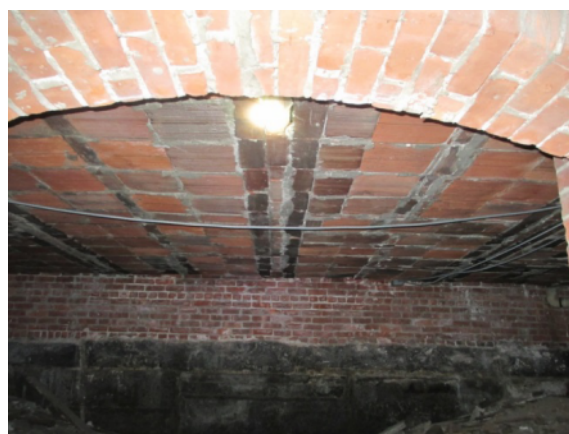
The floor under the narthex differs from the rest of the church; while the main portion of the nave, transept and altar is a wood joist system supported on steel framing, the framing beneath the main entrance is a flat terra cotta arch flooring system (Figure 53). Terra cotta tiles span between steel beams; a central keystone midspan allows the terra cotta to act purely in compression as a flat arch support system. This change in construction was likely due to heavier decorative loads at the narthex compared to the rest of the church: while the main area of the church is tiled with checkerboard tile flooring, the entry has decorative terrazzo flooring and marble-clad walls. The terra cotta flat arch flooring appears to be in good condition.

Figure 53. View of First Floor Structure Beneath Narthex

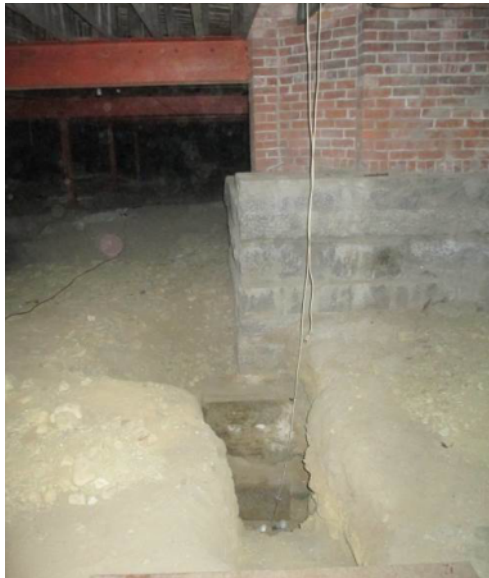
There are four major piers supporting the dome structure at the foundation level (Figure 54). It is unknown whether this load is being carried to the piers by masonry or steel columns. These piers are brick and roughly seven and one-half feet square founded on stone footings set on a concrete mud slab. These robust foundations are in good condition with no visible signs of distress or deterioration.

Figure 54. Stone Foundation for Interior Brick Pier

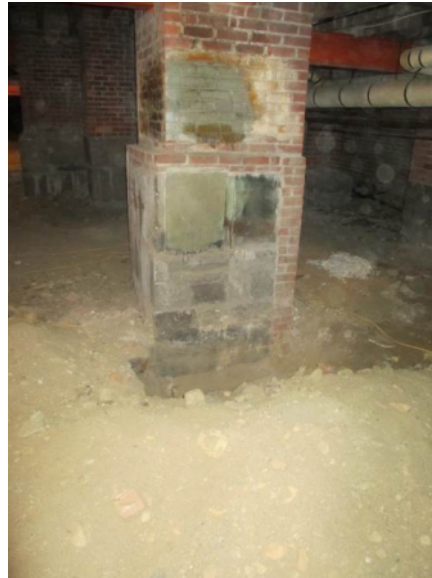
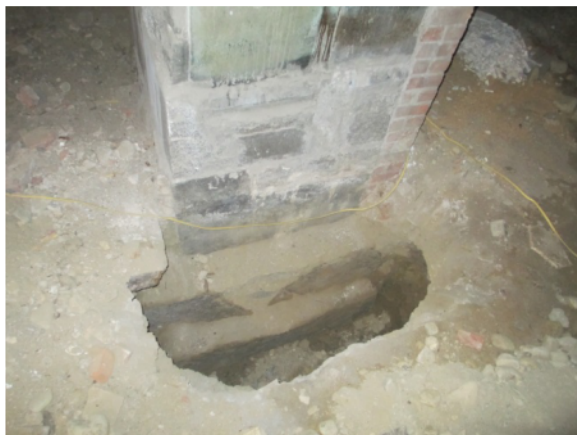
The steel columns are supported on two different types of footings. The major steel columns that are supporting the clerestory walls are supported by three foot square brick piers that are founded on stone footings set on a concrete mud slab (Figures 55 and 56). The remaining steel columns, which are supporting

Figure 55. Brick Pier at Clerestory Column Footings

Figure 56. Stone Foundations Beneath Clerestory Columns

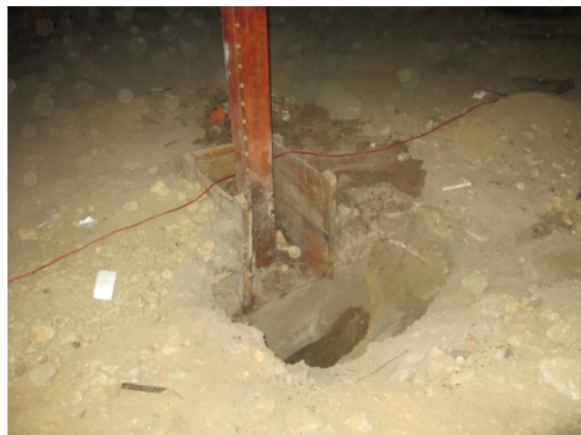
only the first floor framing above, are founded on two foot square concrete footings (Figure 57). These columns also generally have a two foot square wood plank box-out around their base allowing visual access to the base plate; this was most likely shoring to locally insert the interior footings without excavating the entire basement. The columns foundations appear to be in good condition with no signs of structural instability or distress.

Figure 57. Concrete Spread Footing Interior Steel Columns
